ECBC-TR-661

EFFECTS OF VAPORIZED DECONTAMINATION SYSTEMS ON SELECTED BUILDING INTERIOR MATERIALS: VAPORIZED HYDROGEN PEROXIDE

January 2009

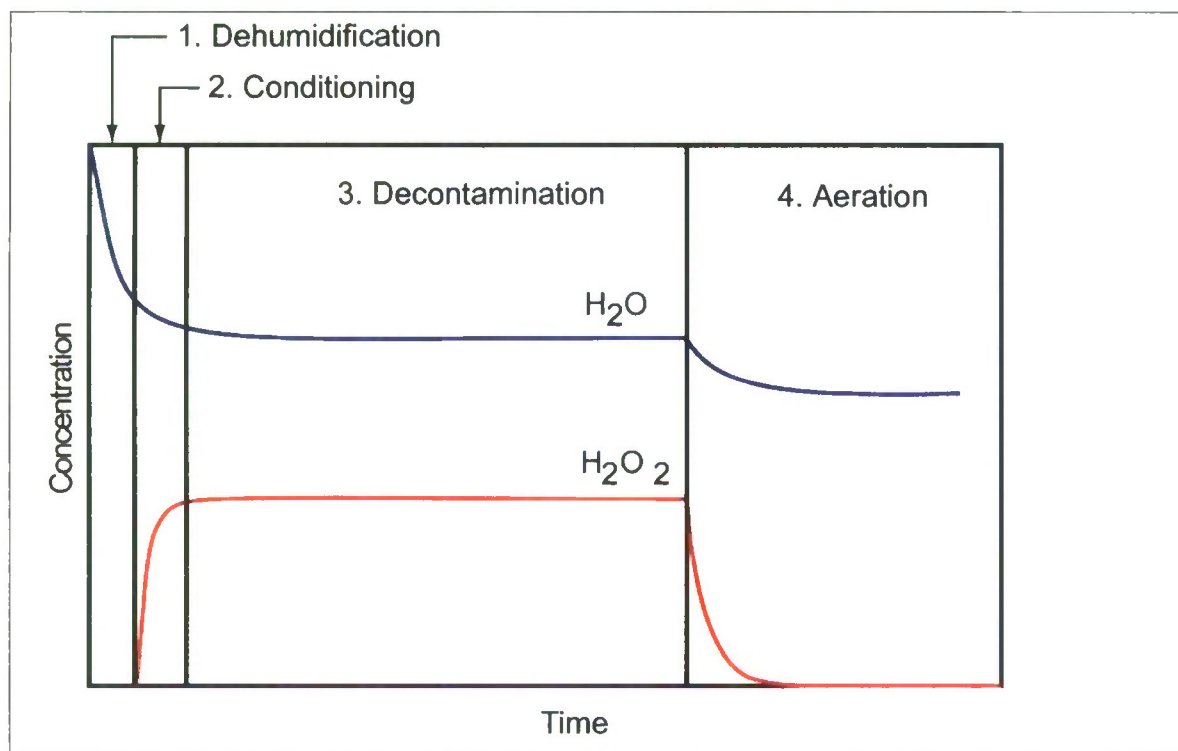
Figure 1. Steris VHP decontamination cycle.

Decontamination of an interior space using VHP is a four-phase process involving preparation of the building interior air (dehumidification), achieving a steady state decontaminant level (conditioning), performing the decontamination, and then aerating for safe reentry (Figure 1).³

(1) Dehumidification: Hydrogen peroxide vapor can co-condense with water vapor, producing an undesired condensate high in hydrogen peroxide. If ambient conditions are likely to permit condensation—high humidity and/or cold temperatures—this can be prevented by circulating dry, heated air through the interior prior to injection of the hydrogen peroxide vapor. The target humidity level is determined by the concentration of vapor to be injected and desired steady state concentration for the decontamination. The lower relative humidity (RH) permits a higher concentration of hydrogen peroxide without reaching a saturation point. For this study, the maximum RH at start-of-run (prior to introducing decontaminant) was 30%.

(2) Conditioning: During the conditioning phase, the injection of hydrogen peroxide vapor is initiated at a rapid rate to achieve the desired chamber concentration set point without condensation. Once the target concentration is achieved, the injection rate was lowered to maintain the set point concentration.

(3) Decontamination: Decontamination is a timed phase dependent on the hydrogen peroxide vapor concentration. In actual building applications, a decontamination timer counts down from the preset decontamination time. If the concentrations or temperature values fall below the set point, the timer stops. This ensures that, during the decontamination phase, the building interior is exposed to at least the minimum decontamination conditions for the desired exposure time. For this laboratory-scale study, the enclosure VHP concentration was maintained within the target concentration range.

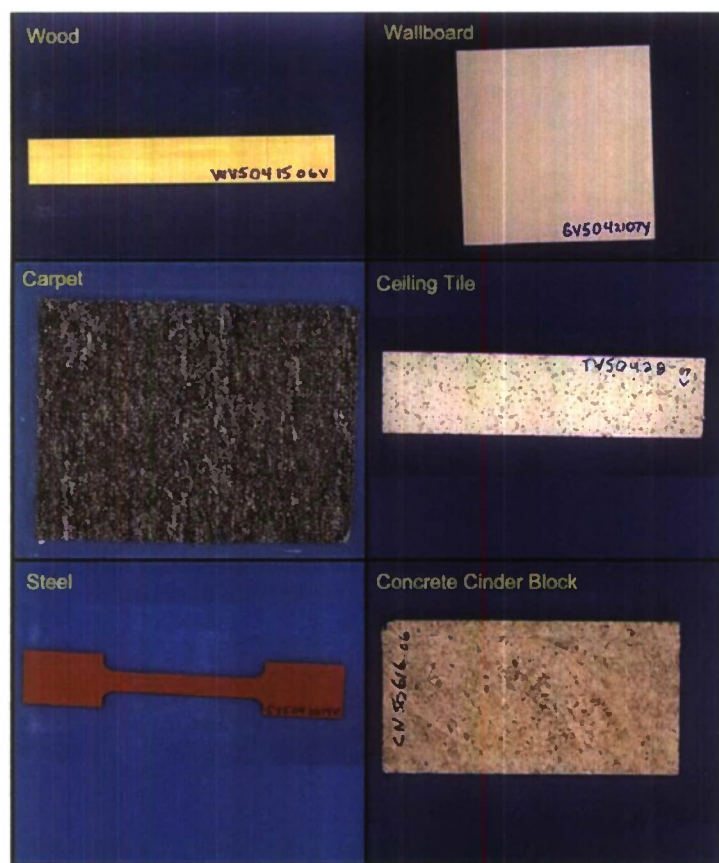
Figure 2. Representative photograph of the test coupons.

The material compatibility studies also investigated materials related to electrical breaker connections such as intact circuit breakers. The circuit breakers were one-pole circuit breakers (HOM120, 2400 watts, 120/240 V, 20 amp).

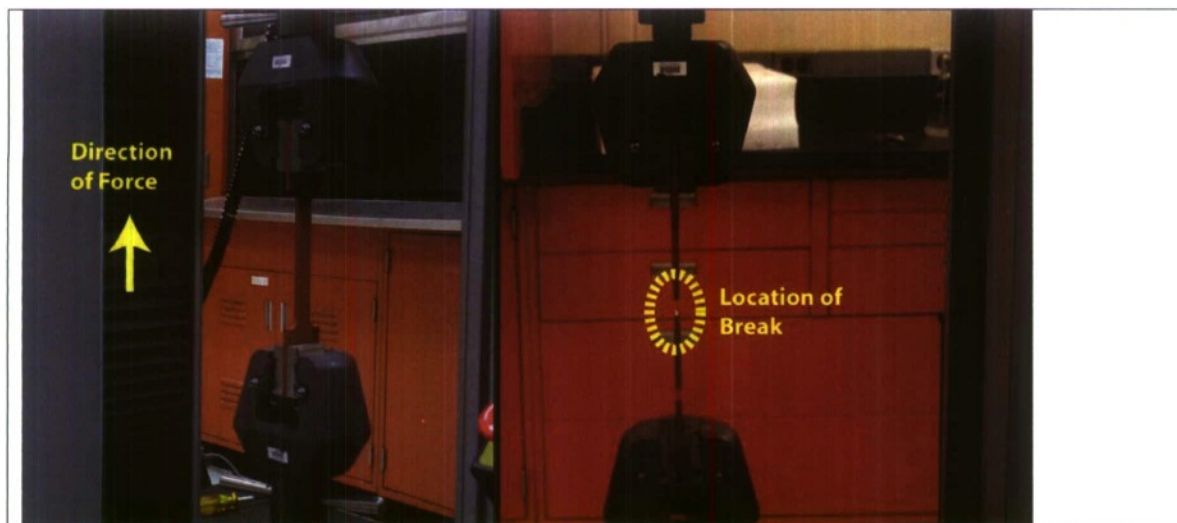
Figure 3. Photograph of the steel coupon test.

The coupons were stored for at least 90 days after fumigation. The actual number of storage days was based on the arrival of the Instron fixtures for testing. The coupons for a particular fumigation were studied after a similar number of days in storage. The load required to rupture the steel coupons, tensile strength results, and number of days in storage before testing values are provided in Table 3.

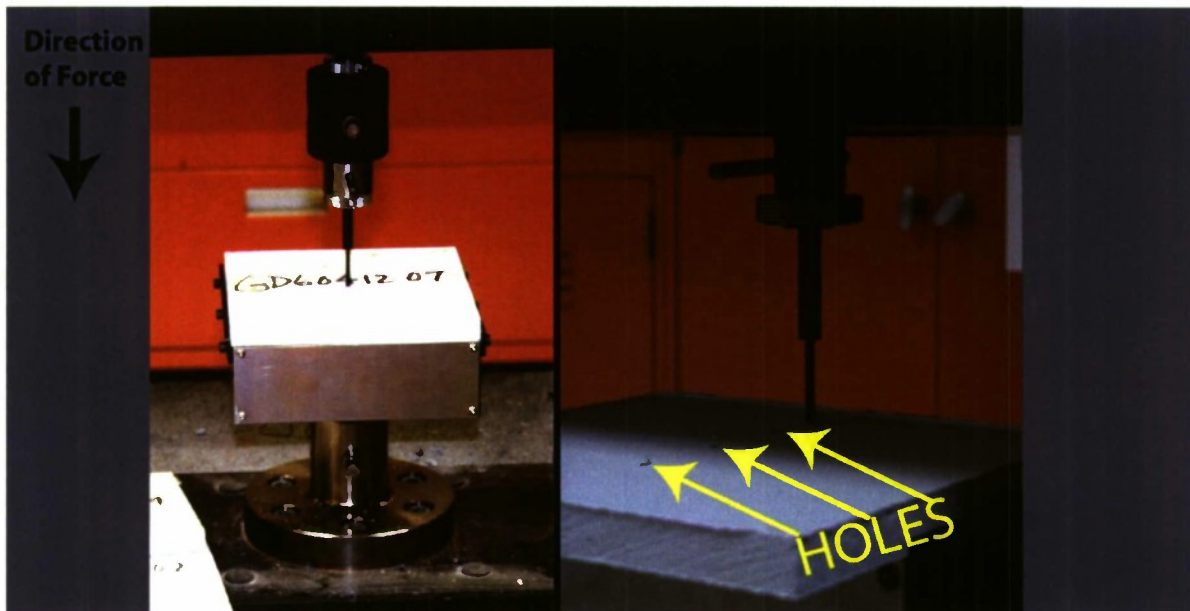
Figure 4. Representative photograph of the gypsum wallboard coupon test.

The gypsum wallboard samples were removed from storage, visually inspected, and measured. The coupons from chamber positions 1, 2, 4, 5, and 7 were selected for testing; the coupons were selected to obtain representation throughout the test chamber. The samples were brought to moisture equilibrium such that the weight of the sample did not change by more than 0.2% on successive weighings at a minimum interval of 2 hr. The sample preparation was conducted within a temperature range of 15–25 °C and an RH of 48–75%. The testing was conducted IAW the ASTM test method C473-03. The Instron fixture for the gypsum wallboard test was installed prior to testing. The Instron universal testing machine operation was verified by suspending a certified weight from the fixture and recording the weight. Three coupons were tested for each concentration (target and half target), and four sets were tested for the controls (0 ppm). The force required to drive a nail shank through the wallboard coupons was measured in N with five replicate measurements made for each coupon (i.e., each coupon was punctured five times). The ASTM method indicates that any coupon measurement in the series that varies 15% more than the average needs to be discarded. If 15% of the coupons deviate from the average, the method states that the test will be repeated. No additional precision or bias requirements have been determined for this test by ASTM. The results of control coupons are compared against decontaminant exposed samples. A statistical analysis of the data was conducted to determine if the decontaminant exposed coupon results were statistically different compared to the control coupons. A photograph of a representative gypsum wallboard sample before and after testing (i.e., holes) is provided in Figure 4.

The average tension test results are 48.6 ± 7.0 N for the control group, 56.6 ± 12.8 N for the half-target group, and 63.3 ± 9.5 N for the full-target group. The Welch's *t* test was used to determine if there were statistically significant differences among the test groups (control, half target, and full target). The control test groups were significantly different from the full-target and half-target coupons at the 95% confidence level. The half-target and full-target coupons were not significantly different at the 95% level of confidence.

These test methods show that exposure to VHP has statistically significant effects on the maximum load of wallboard coupons as determined by the ASTM test method. Exposure to VHP fumigation resulted in an increase in the ability of the wallboard to resist nail pull-through. However, this test does not indicate whether this decrease in maximum load would result in failure of installed wallboard after fumigation.

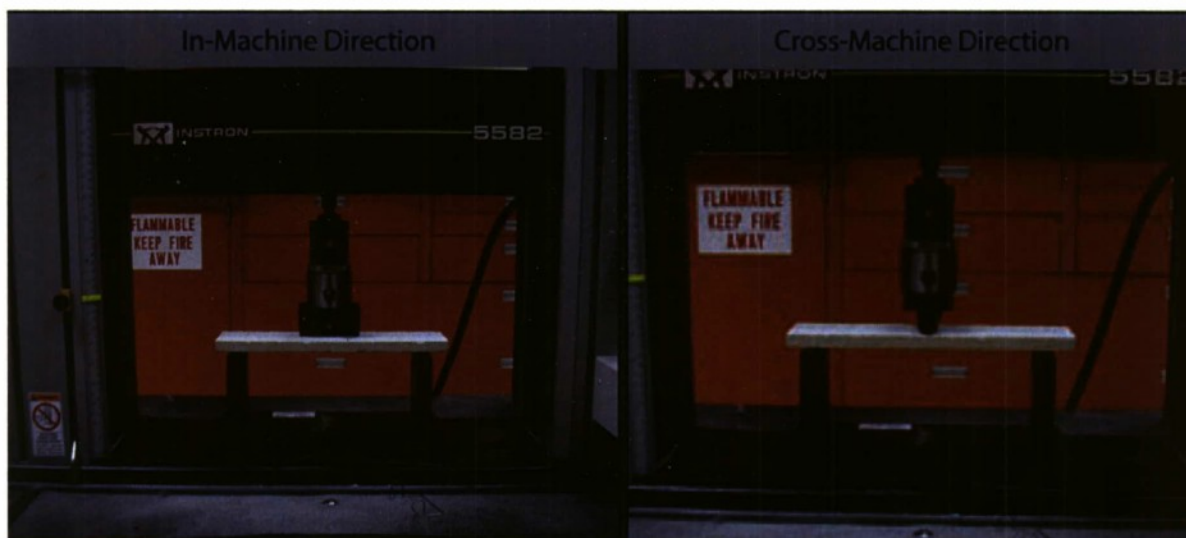
Figure 5. Representative photograph of the acoustical ceiling tile coupon test.

The acoustical ceiling tile samples were removed from storage, visually inspected, and measured. The samples were brought to moisture equilibrium such that the weight of the sample did not change by more than 1% on successive weighings at a minimum interval of 2 hr. The sample preparation was conducted within a temperature range of 18–24 °C and an RH of 48–75%. The testing was conducted IAW the ASTM test method C367-99. The Instron fixture for the ceiling tile test was installed prior to testing. The Instron universal testing machine operation was verified by suspending a certified weight from the fixture and recording the weight. For each test, the coupons from chamber positions 1–8 were selected for testing; this selection consisted of all coupon placed in the chamber during a single fumigation trial. Three sets of four machine-direction coupons and four cross-machine-direction coupons were tested for each concentration (0 ppm, target, and half target). The load required to break the ceiling tile coupons was measured in N. Figure 5 shows a photograph of a coupon loaded into the Instron for the machine and cross-machine direction tests. No precision or bias requirements have been established for this test method. The results of control coupons have been compared to decontaminant exposed tiles. A statistical analysis of the data was conducted to determine if the decontaminant exposed coupon results were statistically different compared to the control coupons.

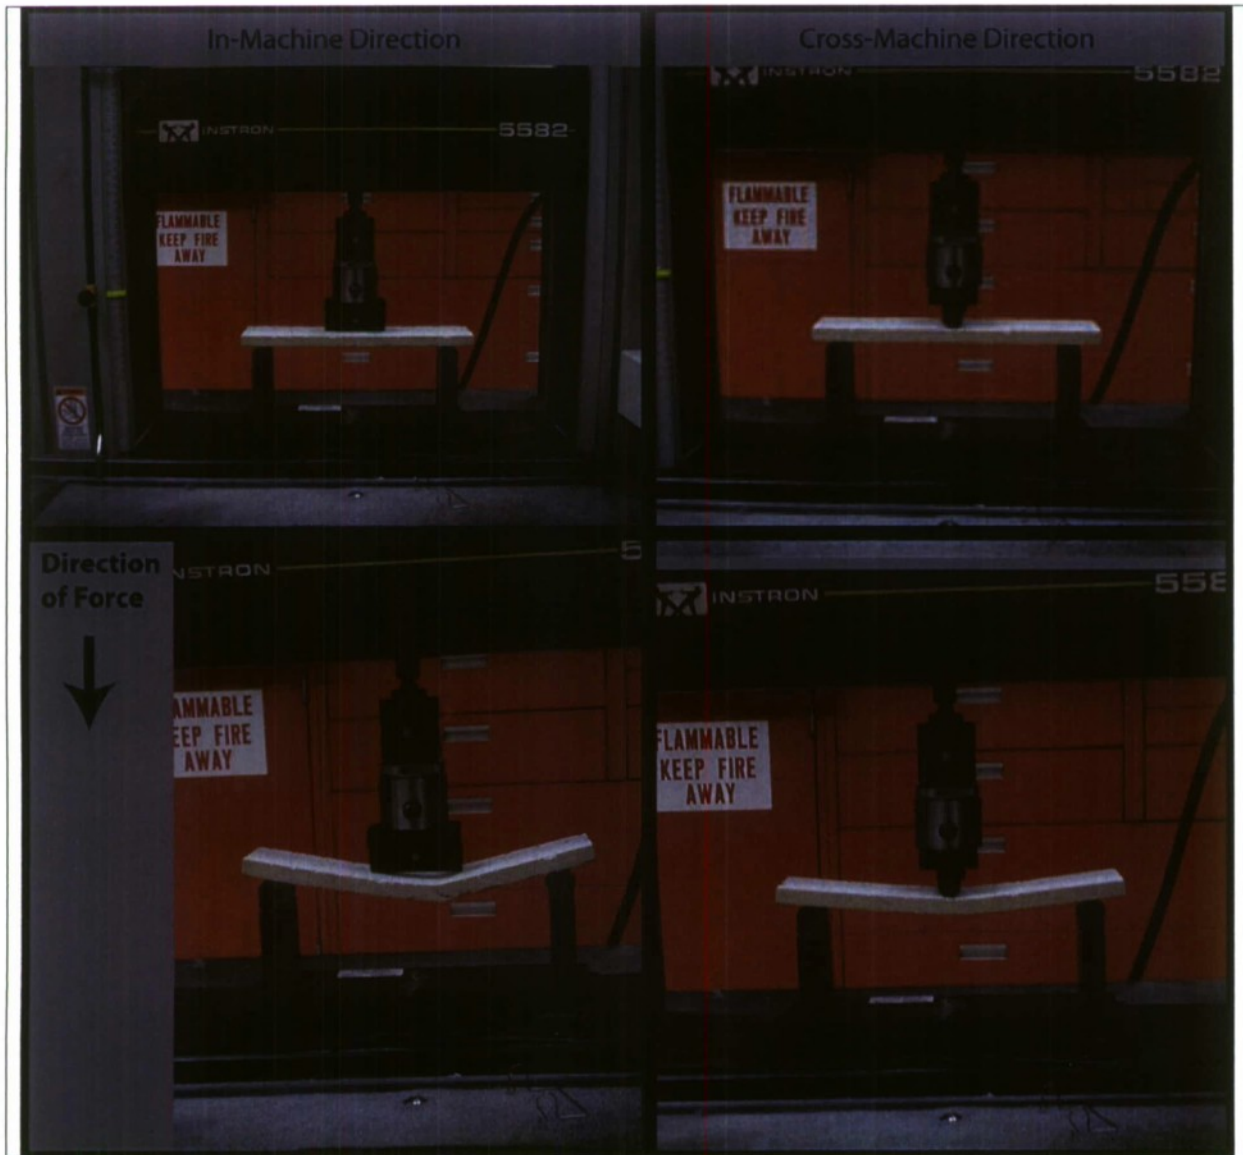
Figure 6. Photograph showing acoustical ceiling tile end of test configuration.

For the machine-direction tests, the maximum load values are as follows: 35.23 ± 4.92 N for the controls, 40.76 ± 5.20 N for the half-target coupons, and 36.63 ± 4.07 N for the full-target coupons. The MORs are: 0.82 ± 0.11 N/mm² for the controls, 0.97 ± 0.15 N/mm² for the half-target, and 0.82 ± 0.11 N/mm² for the full-target coupons.

For the cross-machine tests, the maximum load values are as follows: 28.83 ± 5.02 N for the controls, 32.18 ± 3.22 N for the half-target coupons, and 27.23 ± 3.69 N for the full-target coupons. The MORs are 0.67 ± 0.12 N/mm² for the controls, 0.76 ± 0.07 N/mm² for the half-target coupons, and 0.62 ± 0.08 N/mm² for the full-target coupons.

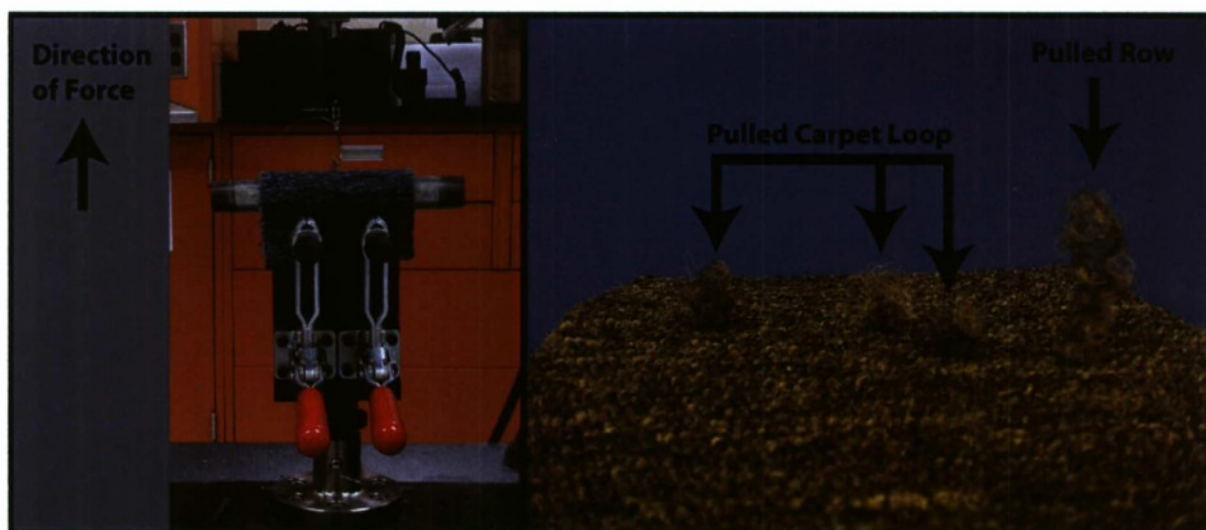
Figure 7. Representative photograph of the carpet coupon test.

The carpet samples were removed from storage, visually inspected, and measured. The coupons from chamber positions 1, 3, 4, 5, and 7 were selected for testing; the coupons were selected to obtain representation throughout the test chamber. The samples were brought to moisture equilibrium such that the weight of the sample did not change by more than 0.2% on successive weighings at a minimum interval of 2 hr. The sample preparation was conducted within a temperature range of 15–24 °C and RH of 48–75%. The testing was conducted IAW the ASTM test method D1335-03, *Standard Test Method for Tuft Bind of Pile Yarn Floor Coverings*. The Instron fixture for the carpet test was installed prior to testing. The Instron universal testing machine operation and calibration verification was conducted by suspending a certified weight from the fixture and recording the weight. Three sets of five coupons were tested for each concentration (target and half target), and four sets were tested for the controls (0 ppm). The load required to pull a carpet loop from the binding was measured in N, and five replicate measurements were made for each coupon. No bias requirements have been established for this test method. The results of control coupons were compared to decontaminant exposed samples. A statistical analysis of the data was conducted to determine if the decontaminant exposed coupon results were statistically different compared to the control coupons. A photograph of a representative carpet sample before and after testing is provided in Figure 7.

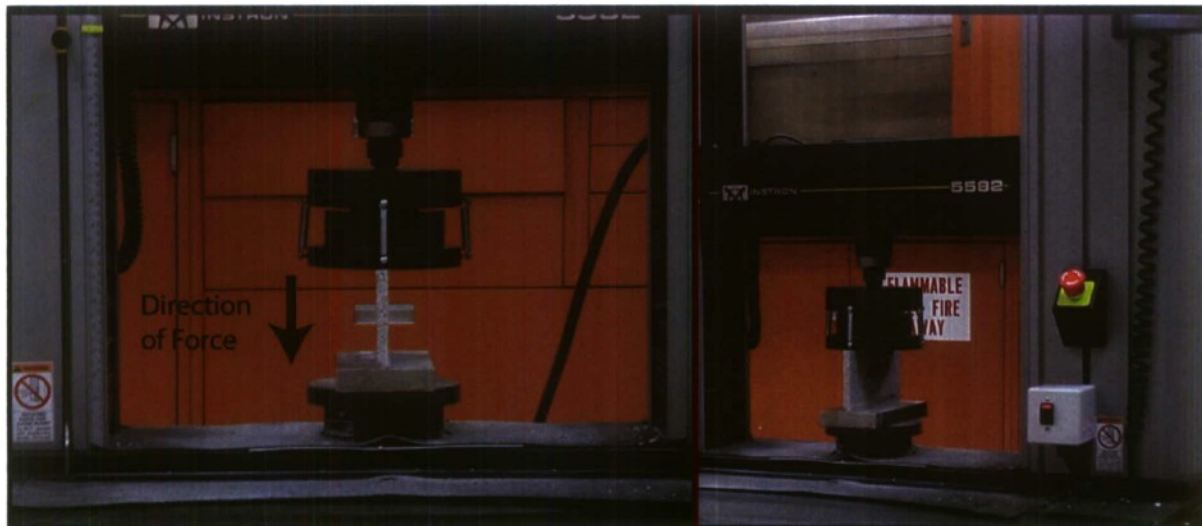
Figure 8. Representative photograph of the concrete cinder block coupon test.

A statistical analysis of the individual test results was conducted to detect potential statistical outliers (Q test) and determine if there are any differences between the control and exposed samples (Welch's t test). None of the coupons could be eliminated as statistical outliers from within their individual test sets or test groups (control, half-target concentration, or target concentration samples) at the Q equals 0.99 level of confidence. A Welch's t test evaluation of the data for maximum load and gross area compressive strength indicates that there are no statistically significant differences among the means of the exposed and control samples at the 95% confidence level. These test methods indicate that exposure to VHP has no significant effect on the maximum load or gross area compressive strength of cinder blocks.

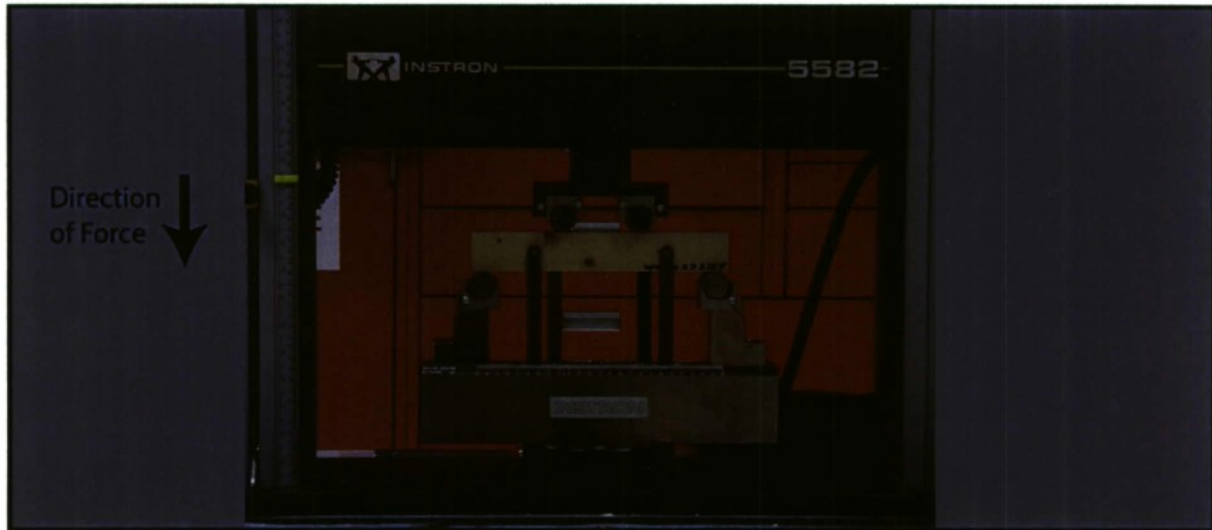
Figure 10. Representative photograph of the wood coupon test.

The wood samples were removed from storage, visually inspected, and measured. The coupons from chamber positions 1, 4, 7, 10, and 14 were selected for testing; the coupons were selected to obtain representation throughout the test chamber. The samples were brought to moisture equilibrium such that the weight of the sample did not change by more than 0.2% on successive weighings at a minimum interval of 2 hr. The sample preparation was conducted within a temperature range of 15–25 °C and an RH of 48–75%. The testing was conducted IAW the ASTM test method D4761-02a, *Standard Test Methods for Mechanical Properties of Lumber and Wood-Base Structural Material*, Sections 6–11. The Instron fixture for the wood test was installed prior to testing. The Instron universal testing machine operation and calibration verification was conducted by suspending a certified weight from the fixture and recording the weight. Three sets of five coupons were tested for each concentration (0 ppm, target, and half target). The load required to rupture the wood coupons was measured in Newtons. The setup of the Instron for testing the wood furring strips can be seen in Figure 10. No precision or bias requirements have been established for this test method. The results of control coupons were compared to decontaminant exposed samples. A statistical analysis of the data was conducted to determine if the decontaminant exposed coupon results were statistically different compared to the control coupons.

The average maximum force value for the control samples was determined to be 4006 ± 861 N. The half-concentration samples were determined to have an average maximum force value of 4431 ± 929 N (an increase of 10.6%) while the target-concentration samples have an average maximum force value of 4725 ± 732 N (an increase of 17.9%).

The average time-to-break value for the control coupons is 3.9 ± 0.9 s. The half-concentration coupons have an average time-to-break of 4.0 ± 0.9 s, and the target-concentration coupons have an average time-to-break of 4.6 ± 0.7 s.

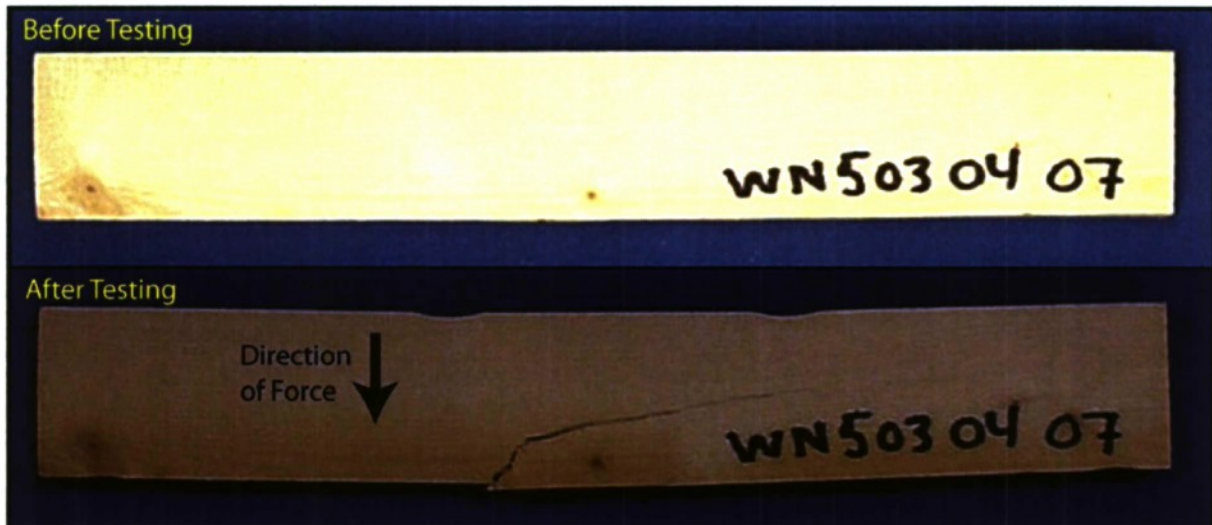
Figure 11. Representative wood coupon before and after testing.

The coupons were stored for at least 90 days after fumigation. The actual number of storage days was based on the arrival of the Instron fixtures for testing. The coupons for a particular fumigation were studied after storage for the same number of days. A photograph of a representative wood sample before and after testing is provided in Figure 11. The wood coupon results for the required load and time to break, moisture content, and number of days in storage are provided in Table 8. The wood samples vary slightly in knot and grain pattern from sample to sample. The break patterns varied from sample to sample; a photograph of each sample is provided in Appendix C.

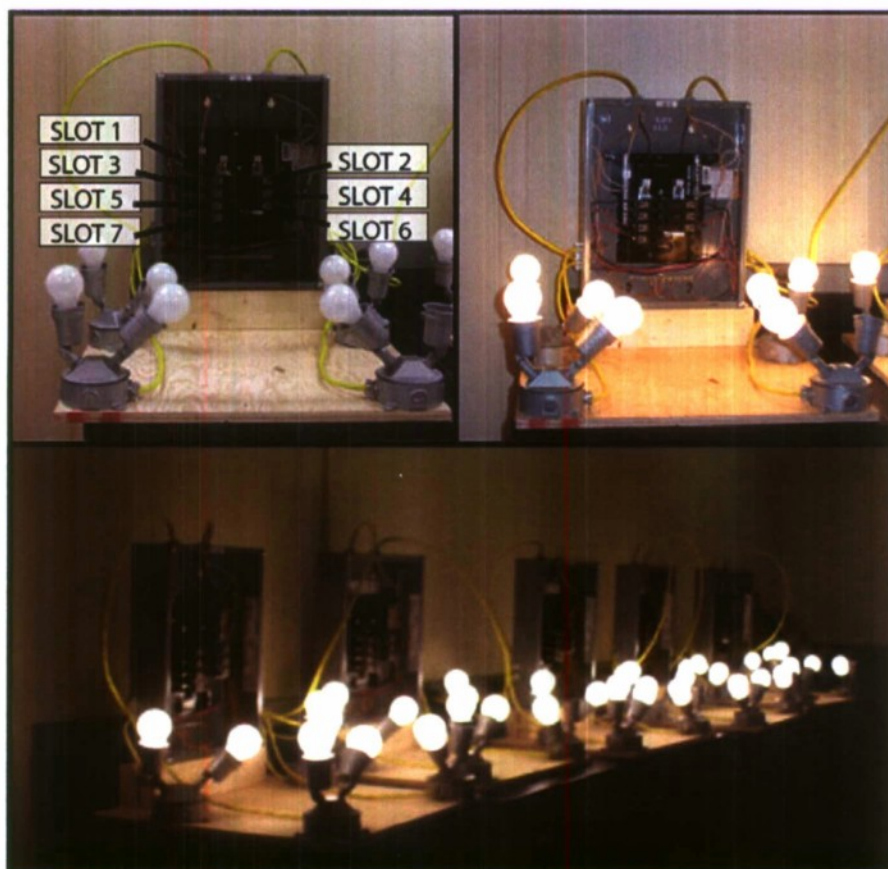
Figure 12. Circuit breaker test station photograph.

After visual inspection, the breakers were installed in the testing station and observed for 90 days under load (Figure 12). The testing station is an electrical box containing 8 spaces, 16 circuits, 100 amp max from square D (Home Depot No. 577-340). The circuit breaker box was wired with 12 gauge, 20 amp wire into the 120 V outlet. Each circuit breaker was wired in series with an electrical lamp (s513e) with an outlet box (s110e) manufactured by Thomas & Betts (Home Depot Nos. c214477 and b214426, respectively). Each lamp contained a Phillips 40 watt light bulb (Home Depot No. a356140). The test or control circuit breakers were installed into slots 1–7, and the baseline circuit breaker was installed in slot 8 (Figure 12, upper left corner).

However, under the 300% challenge (60 amp), a statistically significant decrease in the Time-to-Open due to the 8 hr VHP exposure was observed. No difference was determined to exist between the control set and 4 hr VHP-exposed test group. While no difference was determined to exist between the 4 and 8 hr control groups, the Time-to-Open for the 8 hr VHP-exposed group was statistically significantly different than the 4 hr VHP-exposed group.

These results do suggest that the longer exposure to the fumigant, even at lower concentration levels, did result in a statistically significant effect on the circuit breakers that became apparent at the higher (300% of rated value) test challenge. No specification was found to determine if this effect was within the device failure criteria.

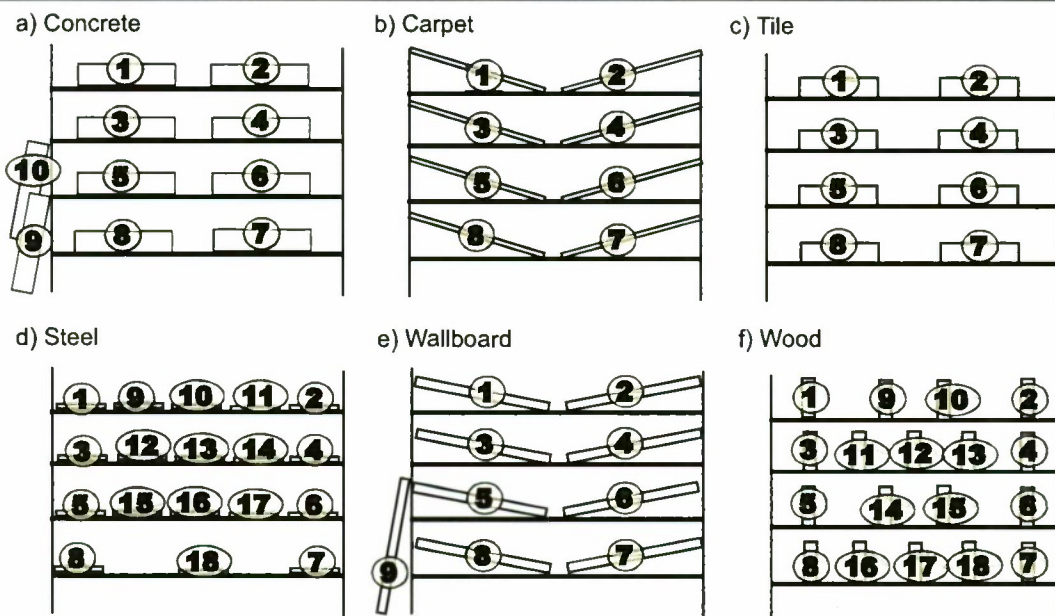
Figure B.1: IOP DS04016 Figure 1, "Coupon Placement in Chambers"

Coupons shown on rack shelves from direction of glove box transfer chamber. Pictorial coupon scaling for length and width is $(0.75 * 2 * (\text{cm} / 10))$.

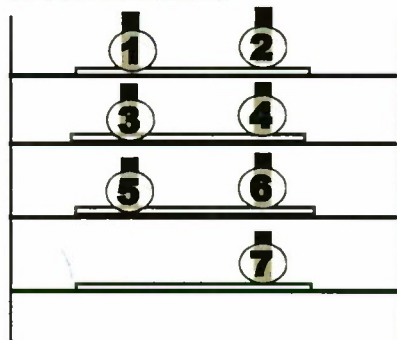
Figure B.2: IOP DS04016 Figure. "Circuit Breaker Placement in Chambers"

Coupons shown on rack shelves from direction of glove box transfer chamber.

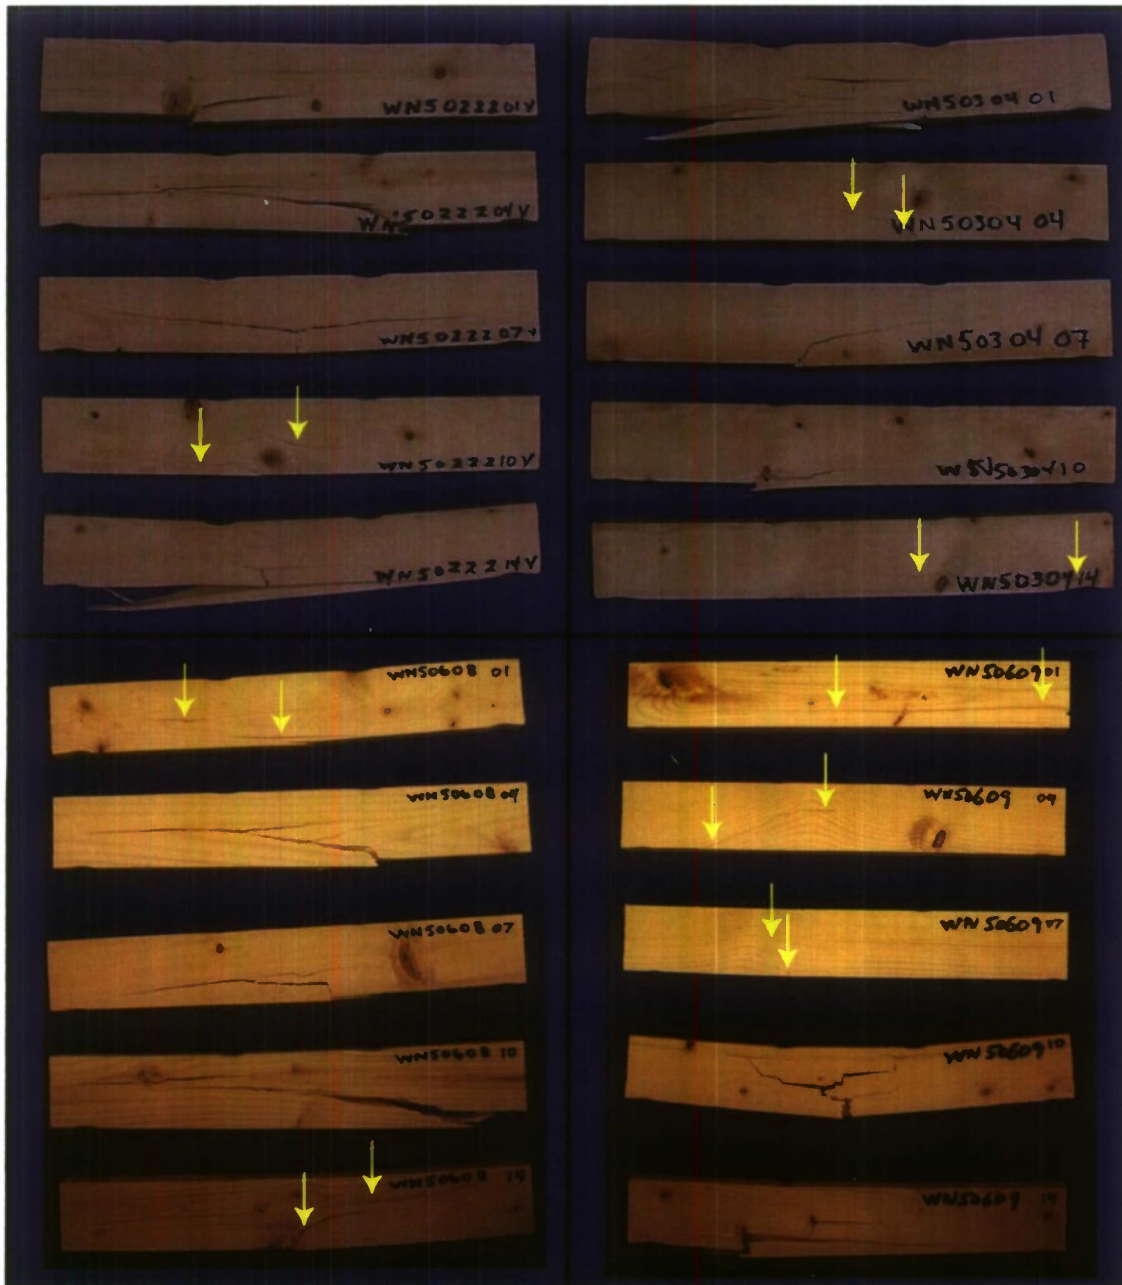
The ASTM test method requires reporting the location of the break for each wood sample. The purpose of this appendix is to provide this reporting information in pictorial form. Yellow arrows are used on samples where the photograph contract may not clearly show the location of the break.

Wood coupon location of break: VHP control set.

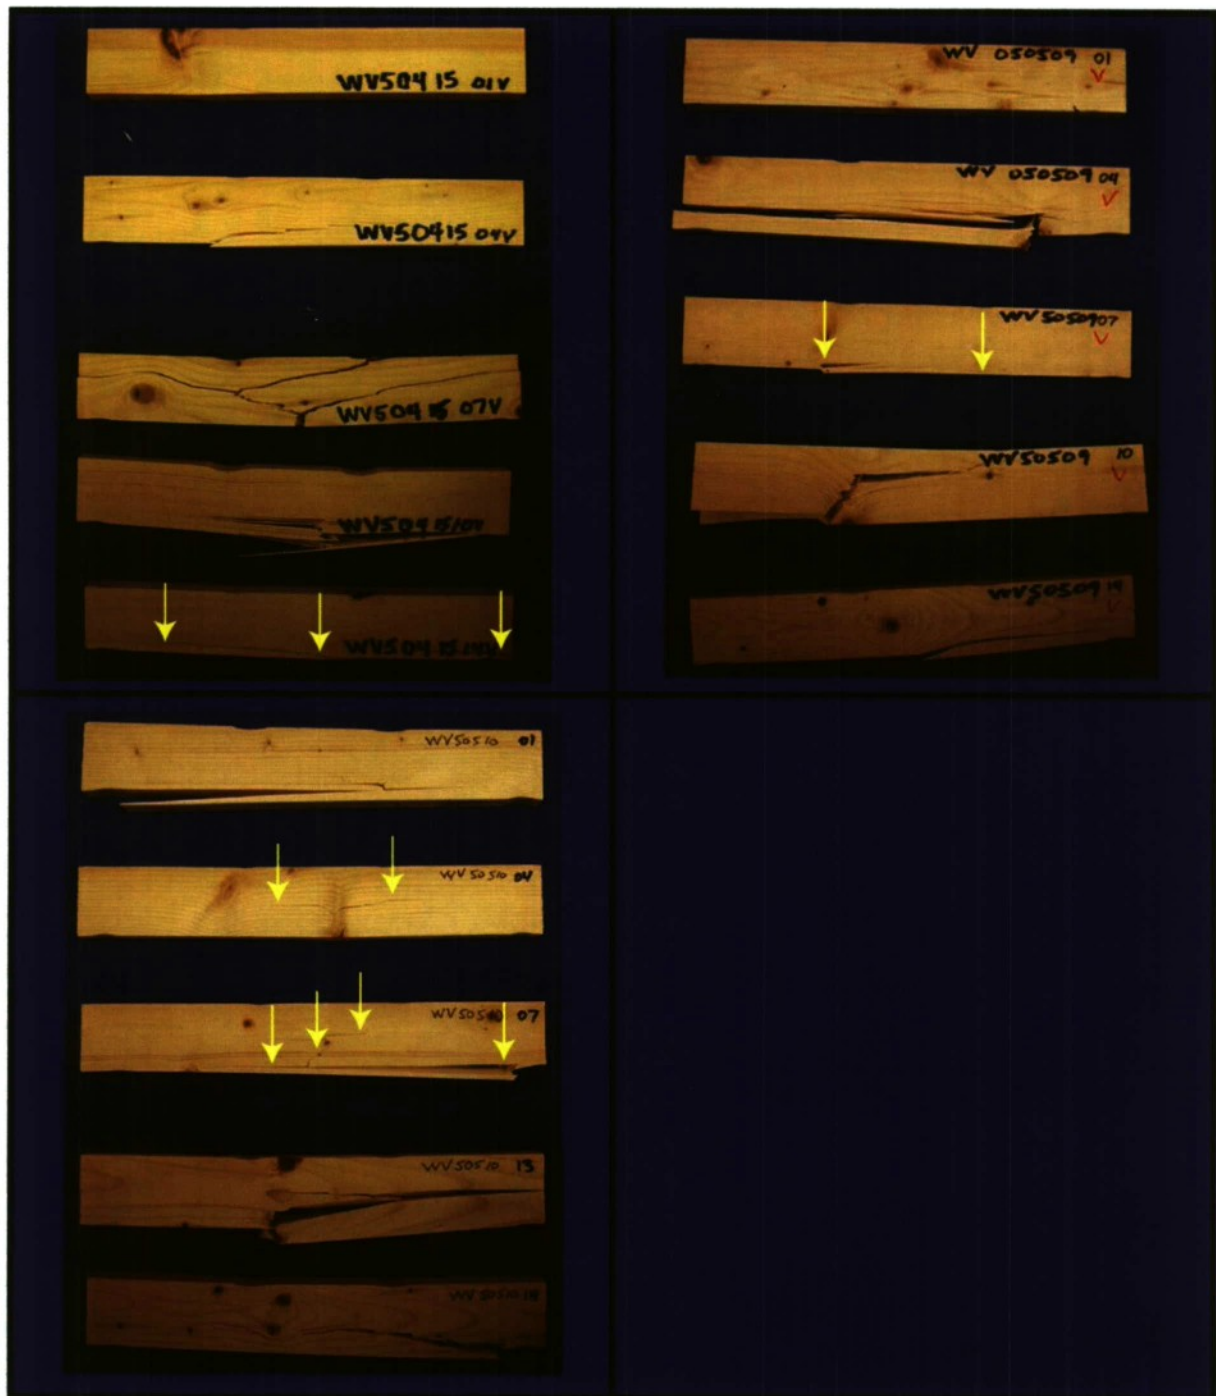
Wood coupon location of break: VHP 125 ppm set.

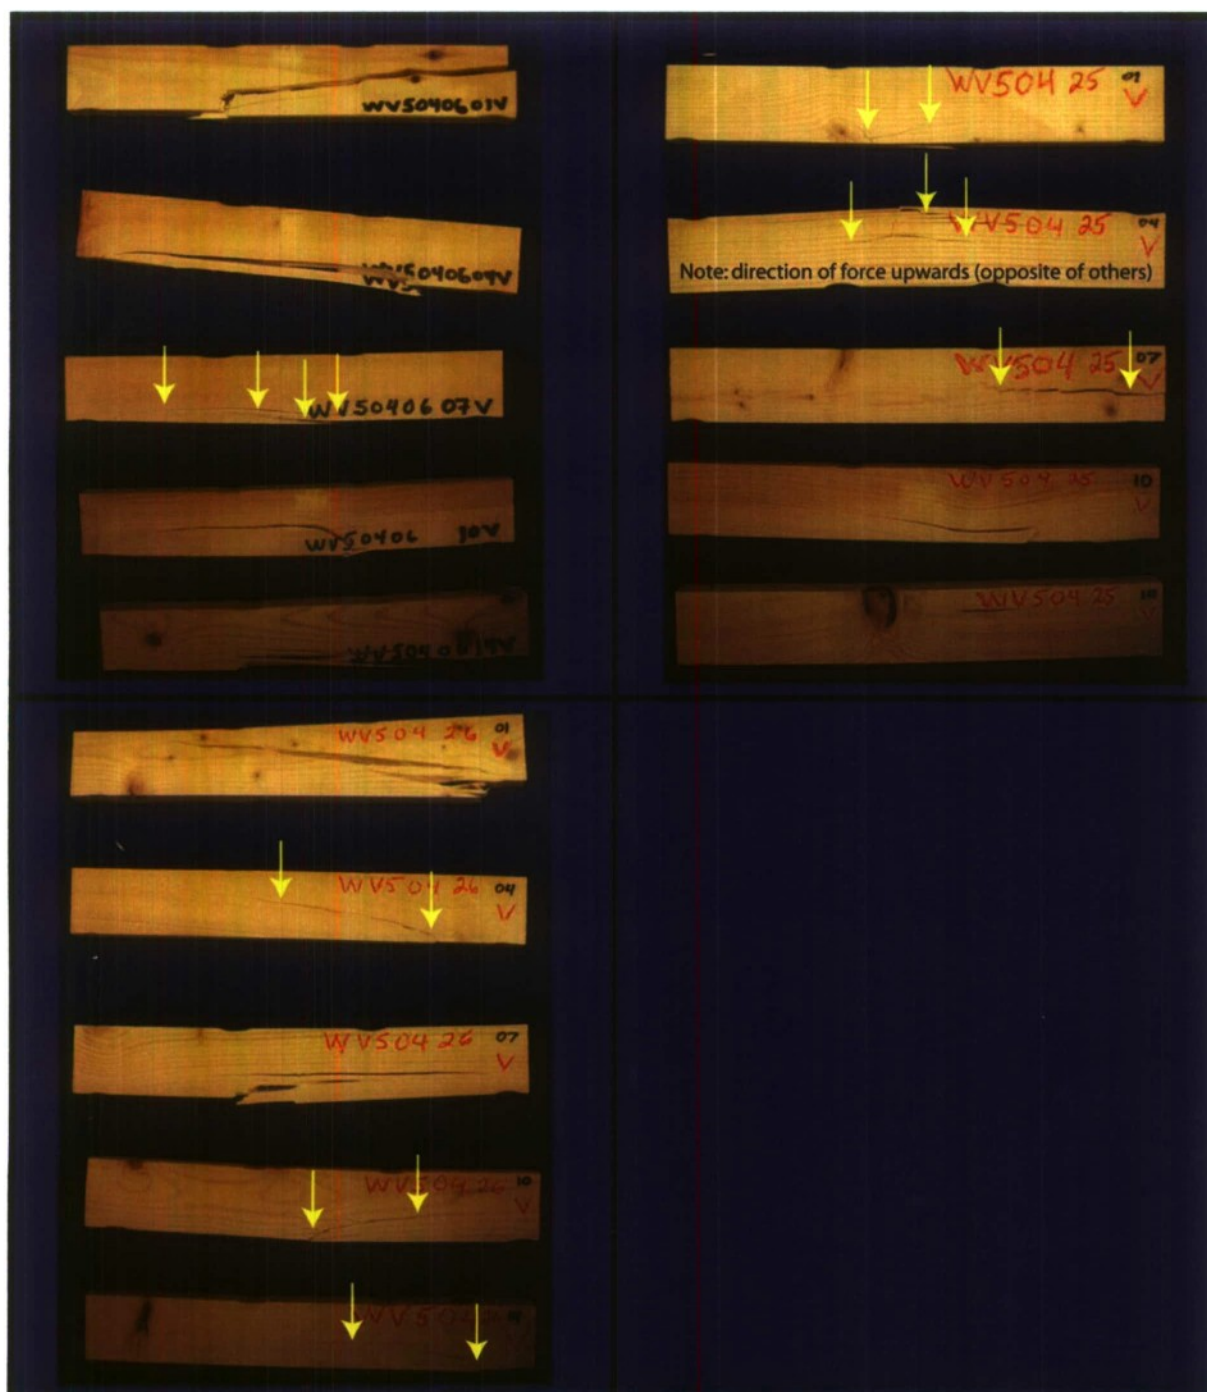
Wood coupon location of break: VHP 250 ppm set.

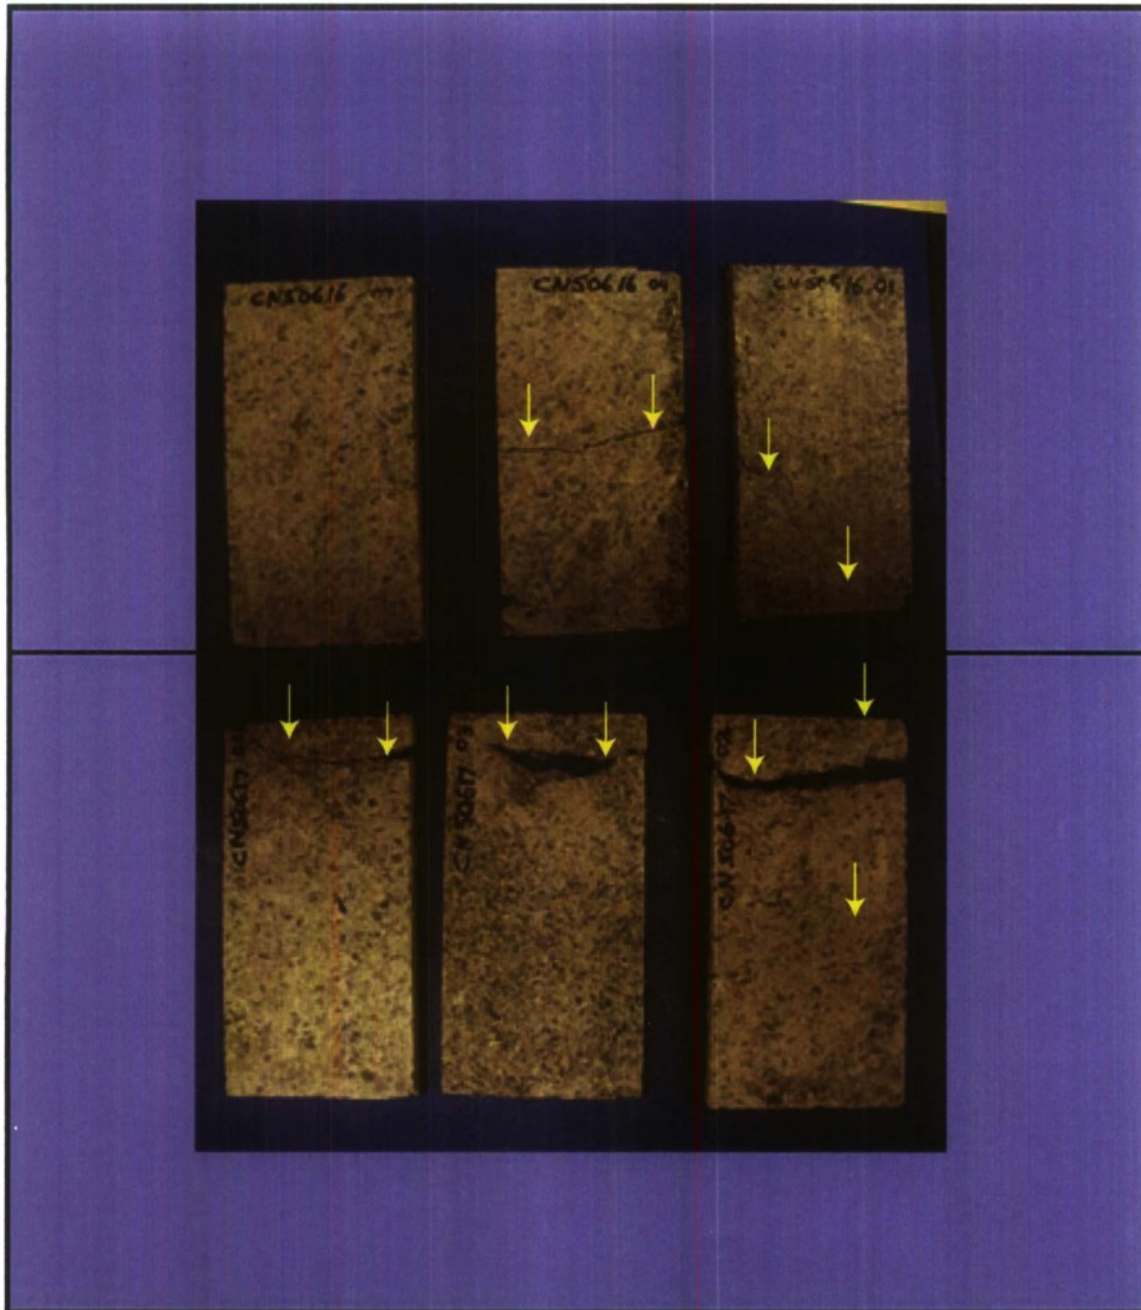
There is no requirement for reporting the location of the break; however, concrete block is a variable material and differences in location were observed. The purpose of this appendix is to provide additional information through test photographs. Yellow arrows are used on samples where the photograph contract may not clearly show the location of the break.

Concrete cinder block coupon location of break: VHP control set.

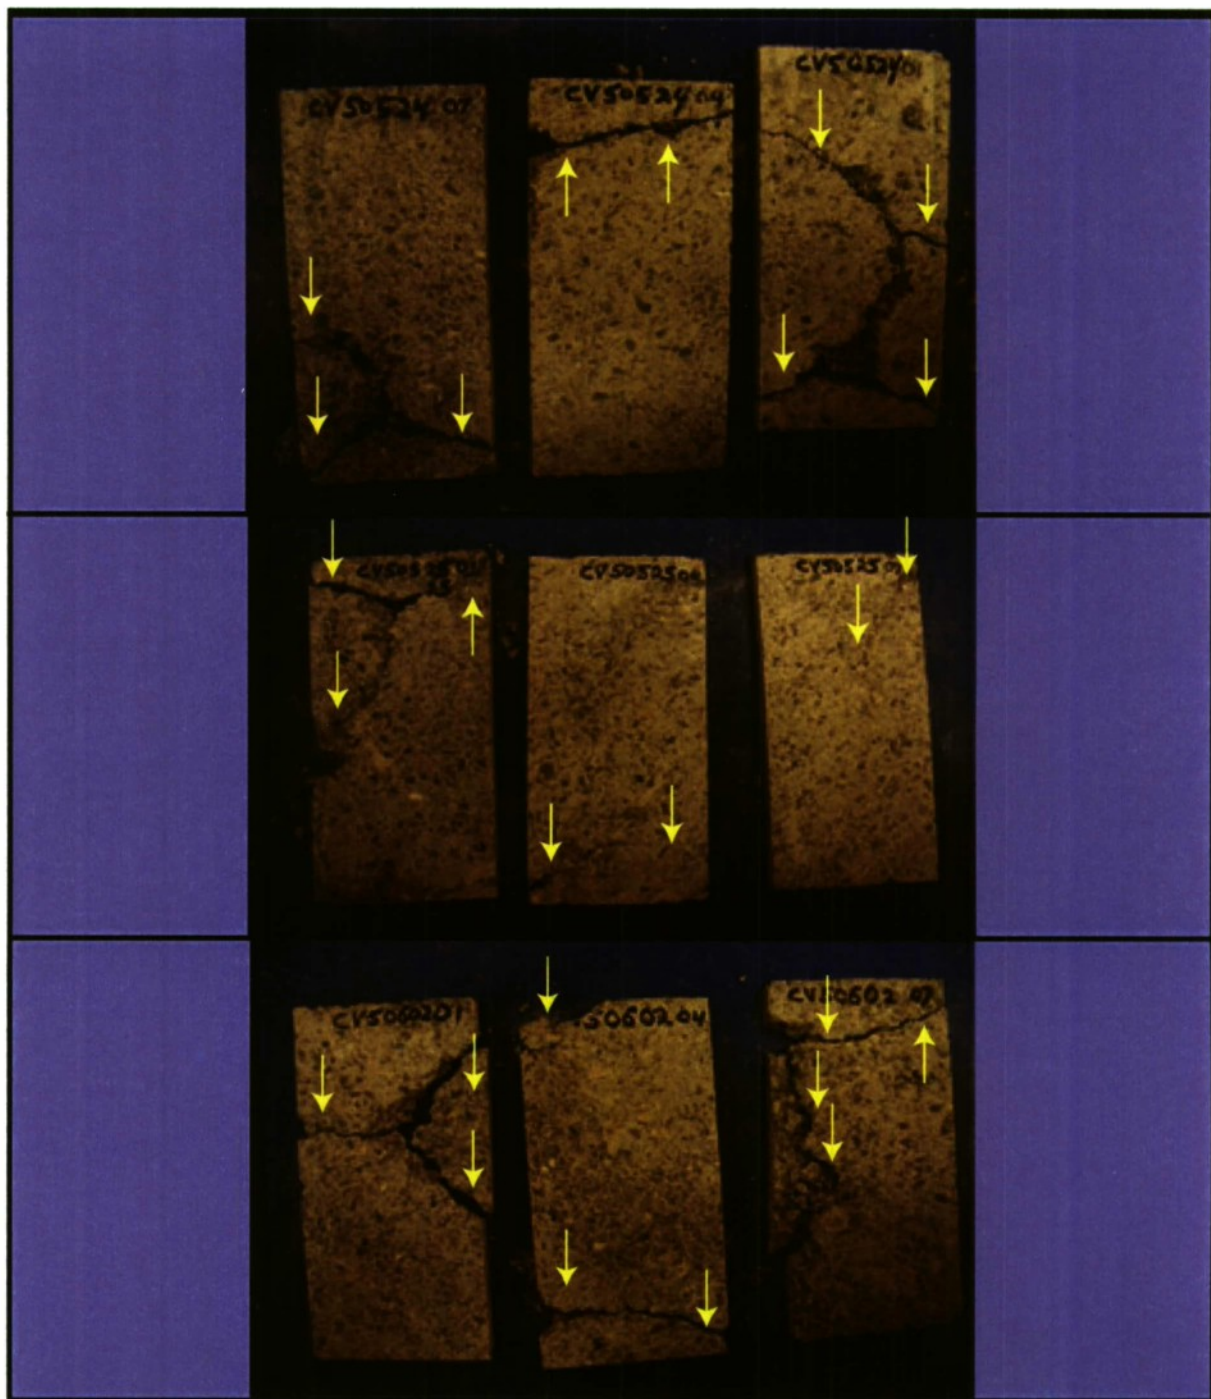
Concrete cinder block coupon location of break: VHP 125 ppm set.
